QUINEBAUG RIVER BASIN
CHARLTON , MASSACHUSETTS

GLENECHO LAKE DAM
MA 00101

PHASE I INSPECTION REPORT
NATIONAL DAM INSPECTION PROGRAM

OCTOBER 1978

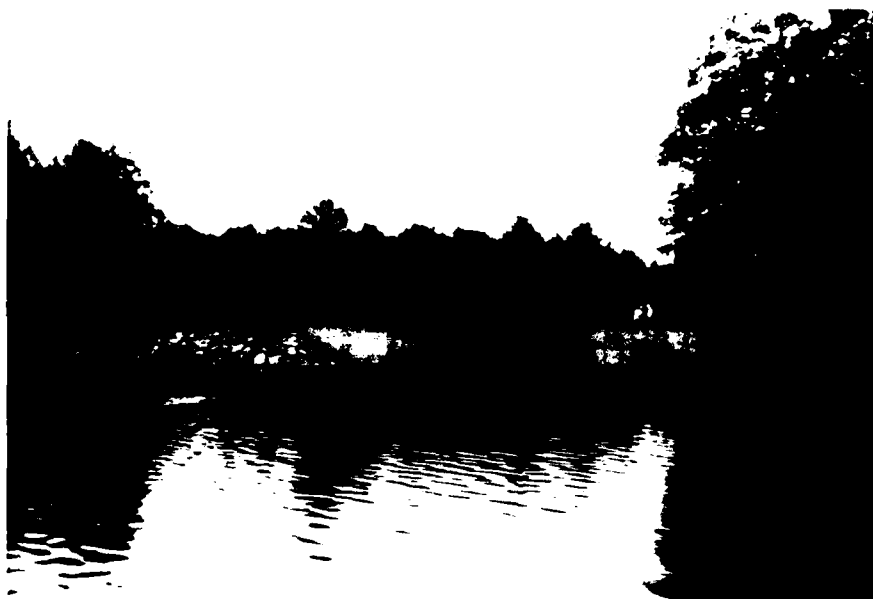
VIEW FROM UPSTREAM OF WEST ABUTMENT
